Manhole Inspection Summary

Manhole # S27A__050MH

Insp Date: **4/16/09 2:56 PM**

Location Address: **1013 MYRTLE AVE**

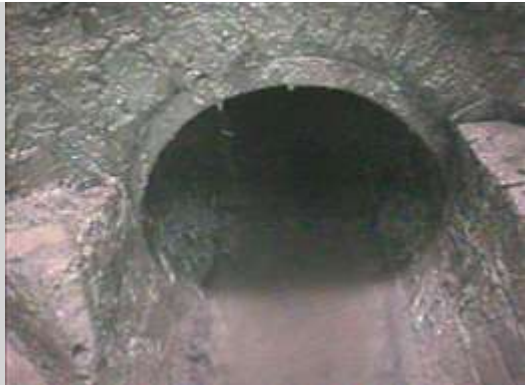
6 O'Clock Inflow

18 in. Circular Gravity Sewer

Pipe In @ 6 O'Clock

Pipe Height: **14.4** (in.) Rod and Bar

Pipe Material: **Clay** ☐ Pipe Lined

Invert Depth: **12.84** (ft.) Flow Characteristics: **Fast**

Deposits: ☒ None ☐ Mud ☐ Sludge ☐ Debris ☐ Grease

Infiltration: **None** Pipe Seal Cond: **Sound**

Drop: **None**

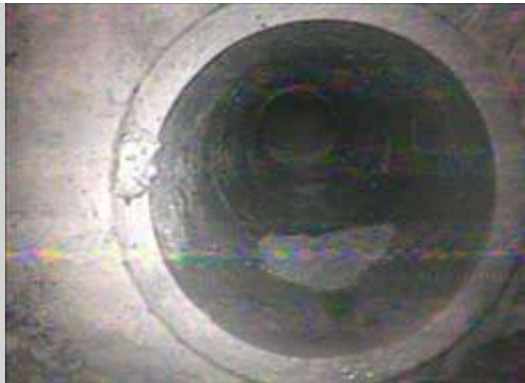
9 O'Clock Inflow

8 in. Circular Gravity Sewer

Pipe In @ 9 O'Clock

Pipe Material: **Clay** ☐ Pipe Lined

Infiltration: **None** Pipe Seal Cond: **Sound**
